## M.A.T. TUBE (MASONRY ABSORPTION TEST)

Masonry Absorption Test  
(MAT Tube)

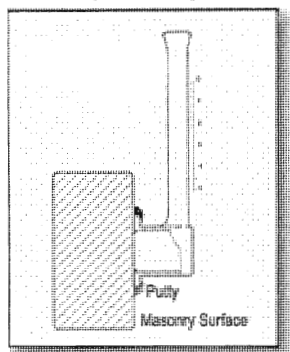
M.A.T. tubes, similar to European RILEM tubes, were developed by **SaverSystems** as a nondestructive field test to evaluate water permeance in masonry structures. The tubes are easily attached with putty to areas where leaks occur, such as head joints, bed joints, or to masonry itself. After water absorption rates are recorded, they may be graphed to identify problem areas.

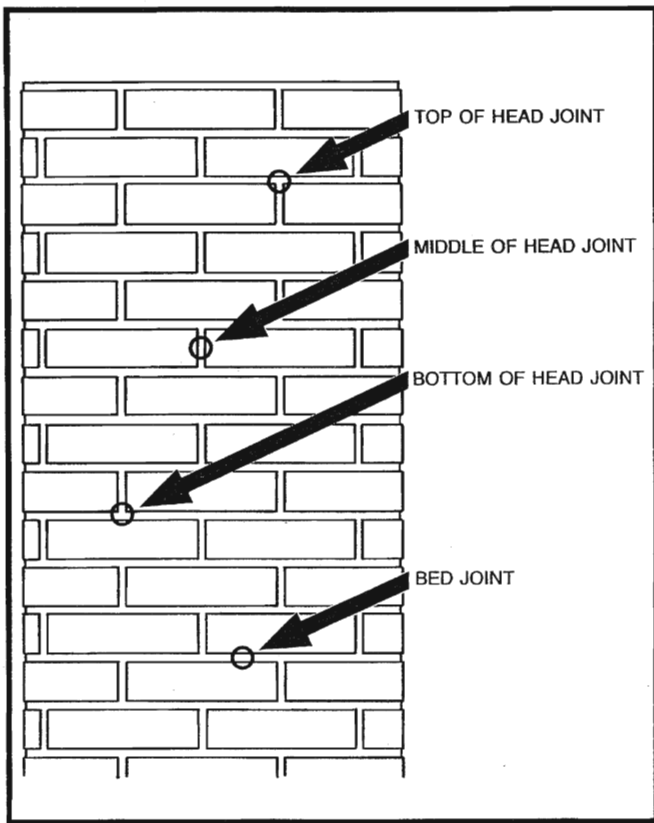
**FIGURE 1 - Mortar Joint Location Types**  
**HEAD JOINTS - (Vertical Joints)**  
**BED JOINTS - (Horizontal Joints)**

1. Decide on placement of M.A.T. tube at a head joint, bed joint, or to the brick itself (**see Figure 1 for location types**). Most leak points occur at the head joint, but can occur wherever there is a poor bond between the brick and mortar. In most cases, it is best to test several joint locations, as well as the surface of a brick, stone, or masonry unit. For accelerated testing, multiple tubes may be used at various locations.

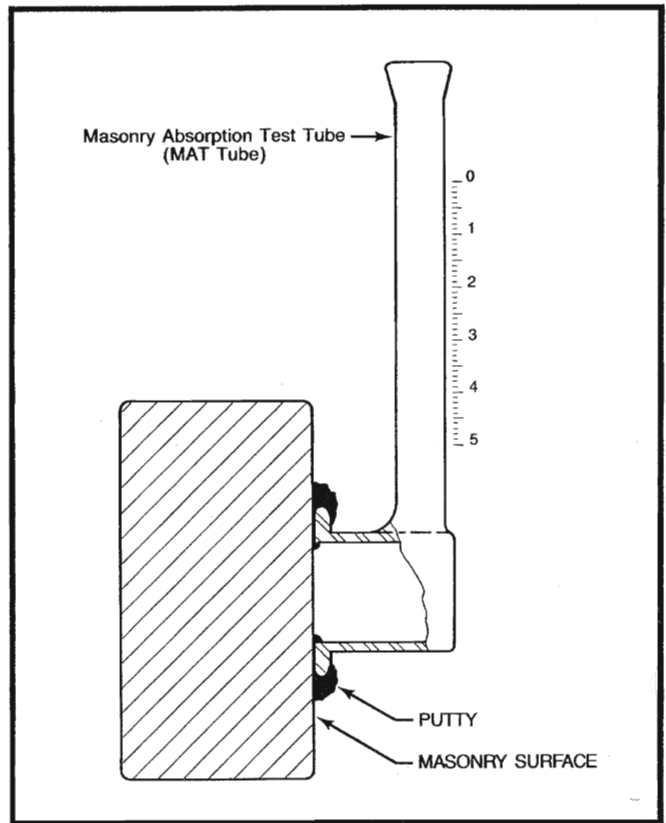
**FIGURE 2 - Detail of MAT Tube attached to a Masonry Surface**

2. Tear off enough putty to create a seal between the tube and the masonry. Roll putty in hands to form a snake-like piece, long enough to place around the the large opening on the tube. Place tube with putty on it at the point you wish to test. Press firmly against wall and form putty around the lip on the tube to make a water tight seal between the tube and the wall (**see Figure 2**).

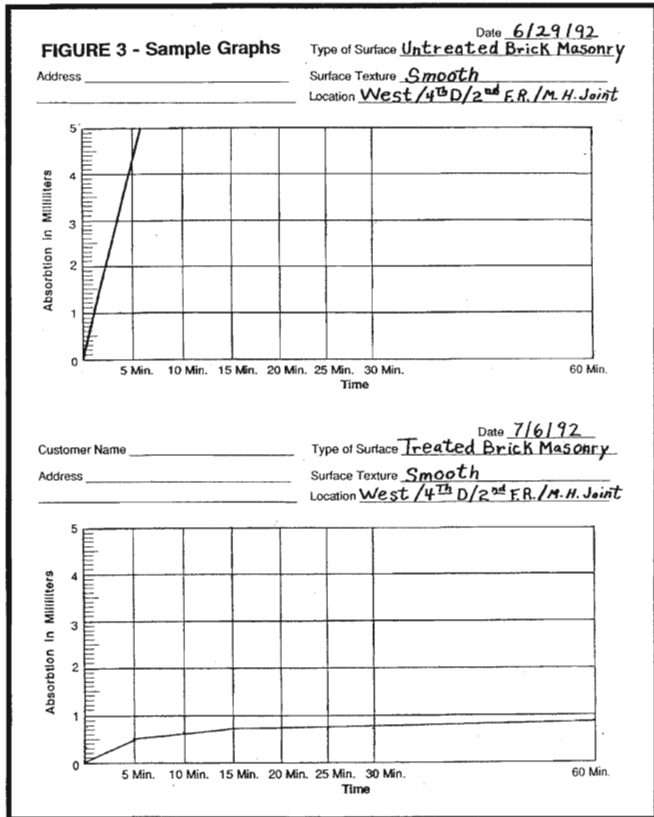
3. Record the type of surface, surface texture, and the location of the point on the wall you are testing in the spaces provided on the absorption graphs (see sample graph in Figure 3).

Fore example, location is indicated in the sample as: West/4th D./2nd F.R./M.H. Joint.

**This simply means: West side, 4th course down, 2nd from right, middle head joint.**

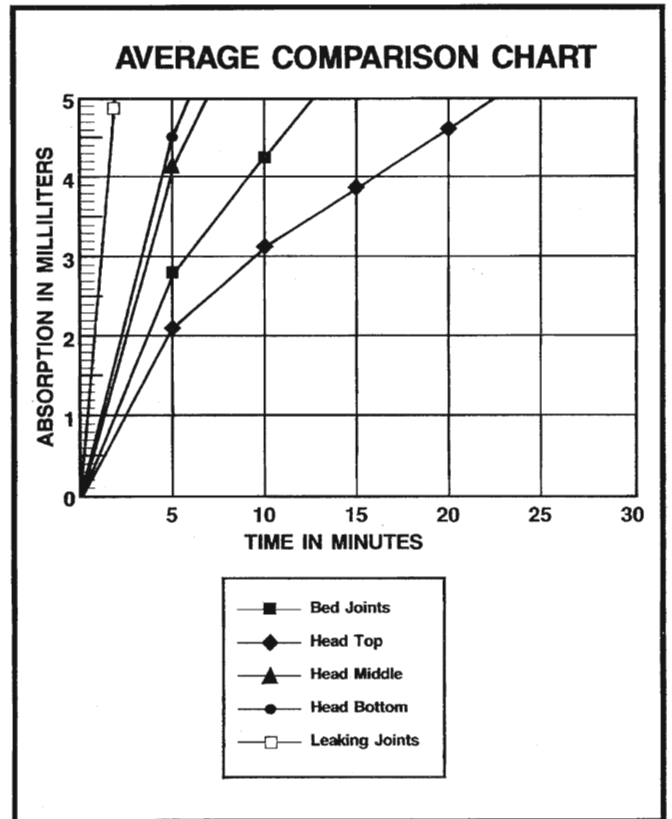
**FIGURE 4 - Average time required for absorption of 5 ml of water for each location type in laboratory test panels.**

The comparison chart (**Figure 4**) is a graph of the average time in which 5 ml. of water were absorbed in 4 by 6 laboratory test panels at each location type (leaking joints, bed joints, and head joints including top, bottom, and middle). Test panels were built by journeyman masons to the "Construction of Brick Masonry" building code requirements for engineers as established by the Brick Institute of America (BIA).

**Note:** The comparison chart in figure 4 represents readings from laboratory test panels built under ideal conditions. The chart is intended to be used as an example of how to graph readings obtained from M.A.T. tube testing in the field. However, potential problems with a wall system are indicated if all 5 ml. of water are absorbed in less than 5 minutes.
